Conference Paper

Proposal of Methodology for Technical Inspection and Rehabilitation Intervention for Multi-family Building of the 60's in Portugal

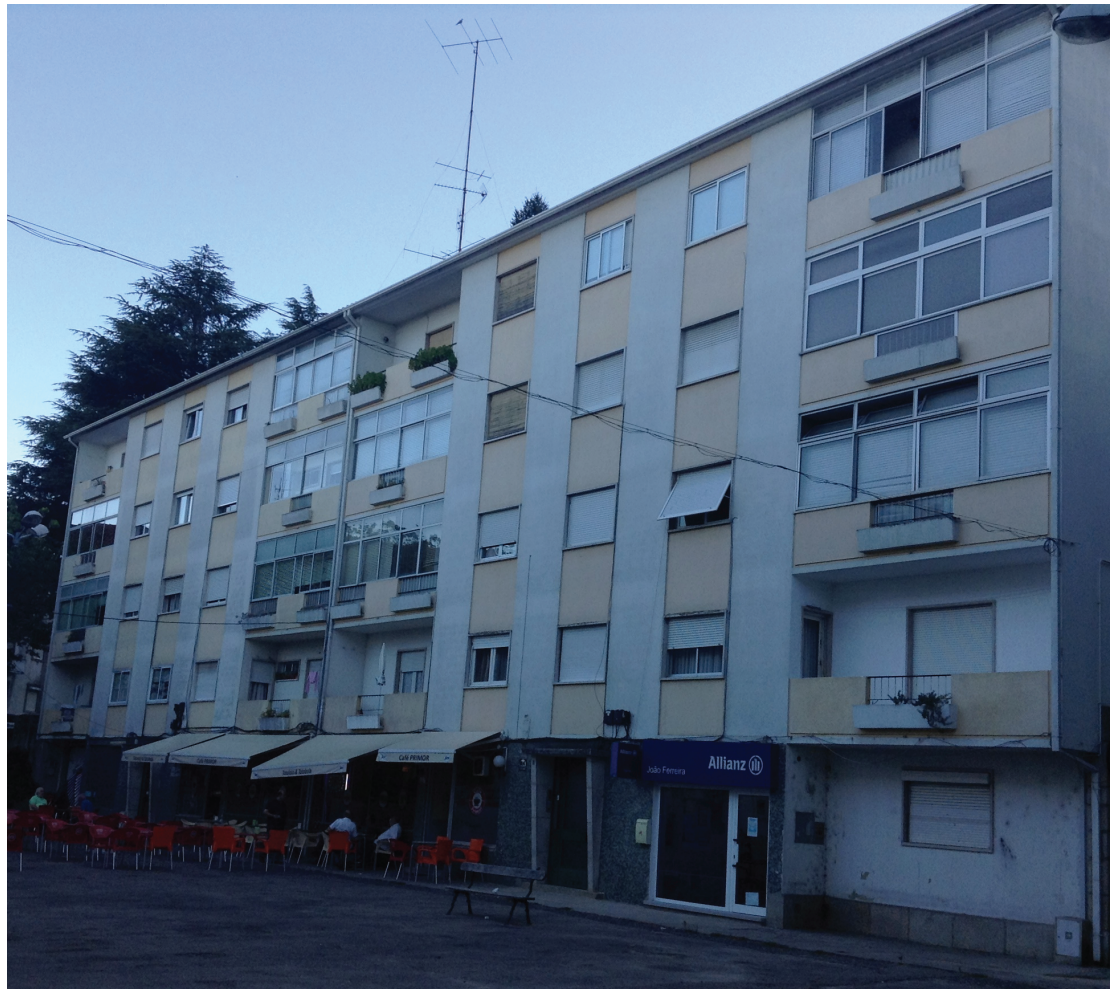
Figure 1: Case study - Multi-family building in Covilhã [1].

It could be concluded that the building under study has been poorly maintained over the years. Taking into account all the analysis performed, it is verified that the thermal discomfort is the most serious problem and that it is urgent to solve.

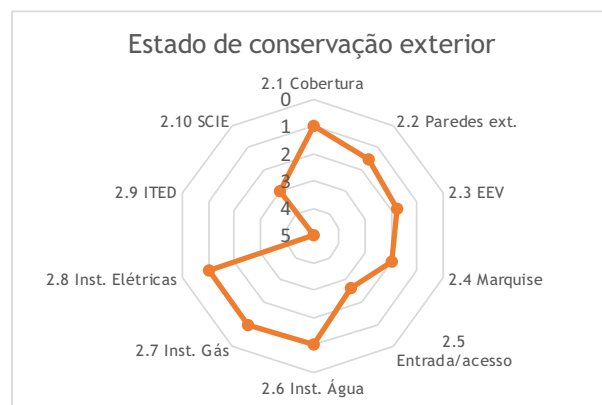
In general, conservation conditions of the apartments are satisfactory, since residents who are almost entirely owners are careful to maintain and rehabilitate some compartments, namely kitchens and toilets. Nonetheless, those are the compartments with the worst classification, similar to the corridors and hall, due to the non-compliance of the general infrastructures. The fraction in worse state of conservation is property of the Municipality that according to the residents only solves serious problems of operation of general infrastructures.

Figure 2: Example of conservation status graph [1].

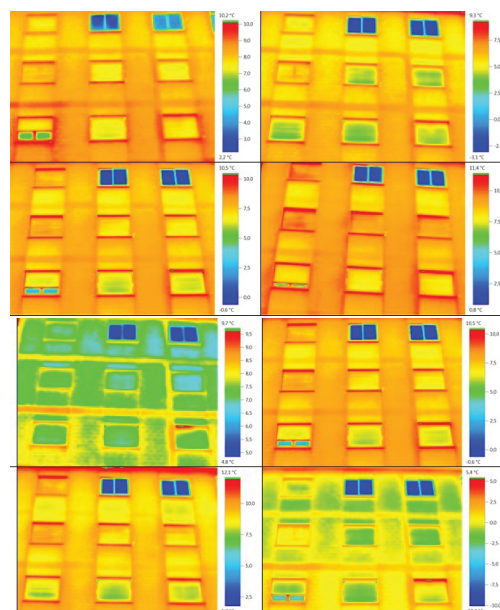
In the collected thermograms (Figure 3) the different temperatures in the envelope of building were observed. The main weaknesses, such as the flat thermal bridges (beams, pillars and shutters), the linear thermal bridges in the glazed spans and the cover slab, the sill and lintel were verified. As for the anomalies detected only “ghosts” were observed in the main façade.

Figure 3: Examples of thermograms - Main façade [1].

It is important to note that the coffee has higher temperatures than the rest of the façade, which means that the ambient heating would be in operation. The rear façade is warmer when measured at night due to the use of the kitchen. Likewise, the toilet facilities are warmer when measured in the morning.
