Conference Paper

Analysis of Surface Orange Peel of Automotive Aluminum Alloy Pipe Using Electron Backscatter Diffraction (EBSD)

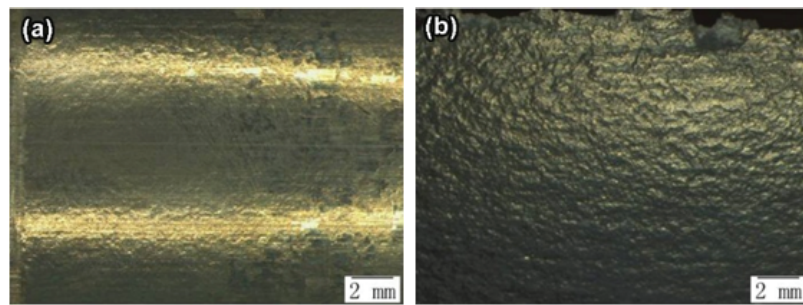
Figure 2: Surface morphology of the tube: (a) before deformation and (b) after tube hydroforming.

Fig. 2 shows the surface morphology of the tube before and after its hydroforming. Prior to deformation, a smooth surface morphology of the tube is presented in Fig. 2a. The pronounced ups and downs called orange peel found at the edge of rupture area are shown in Fig. 2b. All the samples were cut from the two areas for further analysis by EBSD of the cause of formation of the orange peel defects.

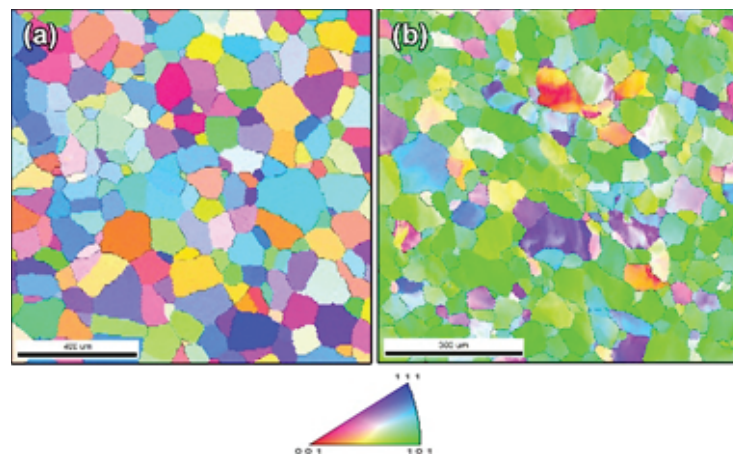
Figure 3: Crystal orientation map in inverse-pole-figure coloring of the surface samples: (a) before deformation and (b) after tube hydroforming.

The crystal orientation maps in inverse-pole-figure coloring of the surface with respect to the axis of the tube are shown in Fig. 3. The color key indicates the grain orientation. As it is seen the grains demonstrated random orientation distribution before deformation (Fig. 3a). A slight tendency toward to the $\langle 101 \rangle$ orientation can be found after tube hydroforming as shown in Fig. 3b. Additionally, the normal orientation maps analysis performed with EBSD indicated that the average grain size at the surface was about $120 \mu\text{m}$ (Fig. 3a).

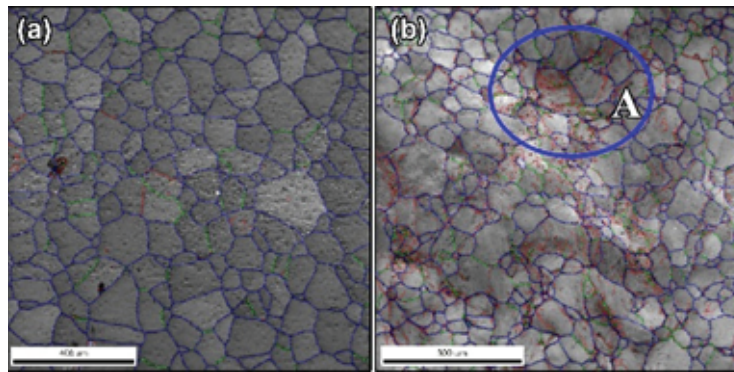
Fig. 4 presents the grain boundary maps at the surface of the samples, showing the evolution on the surface morphology during hydro-bugling. Fig. 4a demonstrates the well-known fact that most grain boundaries at the tube surface are high angle boundaries with the misorientation angles $>15^\circ$. However, the number of grains boundaries with low angle boundaries (angles $<15^\circ$) increased during tube hydroforming. This indicates that the nonuniform deformation exists in these areas, as shown in Fig.

Figure 4: Grain boundary maps from EBSD data of the samples: (a) before deformation and (b) after tube hydroforming.

4b. The pronounced concave-convex uneven surface morphology is observed in the grain boundary map. In the concave areas (A area), a number of grains with low angle boundaries, but not individual out-of-plane displacements, were registered [5]. In addition, the morphology of orange peel resulting from anisotropy of tube hydroforming is inconsistent with the anisotropy of plastic strain inside grains. By analysis of the angle misorientation in the studied sample area using EBSD data, the crystallographic orientation of all grains can be determined, which makes possible to calculate the misorientation between neighboring grains [3]. Fig. 5 shows the misorientation angle distribution of the grain boundaries in the sample. Prior to deformation (as shown in Fig. 5a), the distribution of misorientation angles concentrates mainly within the high angle range and the average misorientation angle is 35.4° . The distribution of misorientation angles in the orange peel area extends to low angles range (the angles $<15^\circ$), as shown in Fig. 5b.

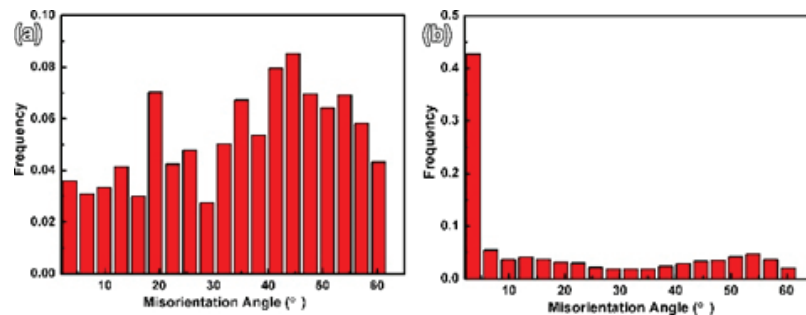
Figure 5: Misorientation angle distribution of the grain boundaries of the samples: (a) before deformation and (b) after tube hydroforming.

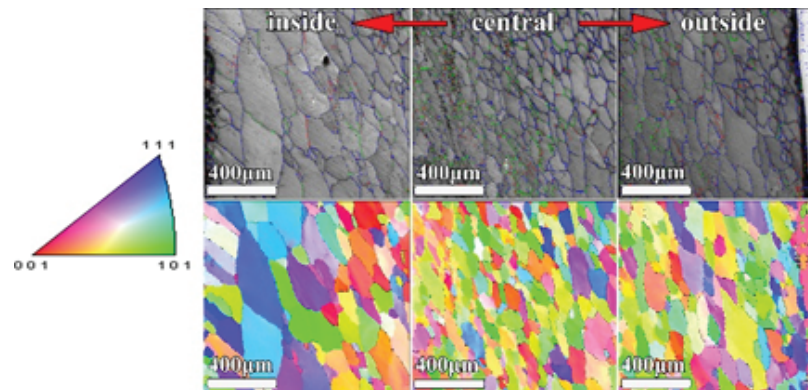
The variation trend of the grain characteristic along the thickness direction can provide better understanding of orange peel arising at the surface after tube hydroforming. Fig. 6 shows the dependence of grain boundaries distribution and orientation maps obtained from EBSD data on the thickness in the undeformed tube. The high angle boundaries with the angles exceeding 15° along the thickness direction play the dominant role in the three areas, which corresponds to the results shown in Fig. 4a. We have also found that the grain size in the central area is smaller than in the other areas. The random orientation distribution of the grains is observed in these areas, especially at the edge regions of the outside and inside areas. The non-uniform distribution of

Figure 6: Grain boundary (top) and crystal orientation (bottom) maps in the thickness direction (before deformation).

grains in the thickness direction has been also revealed. The coarse-grain leads to the orange peel defects with a cube texture during deep drawing in st14 steel sheets.

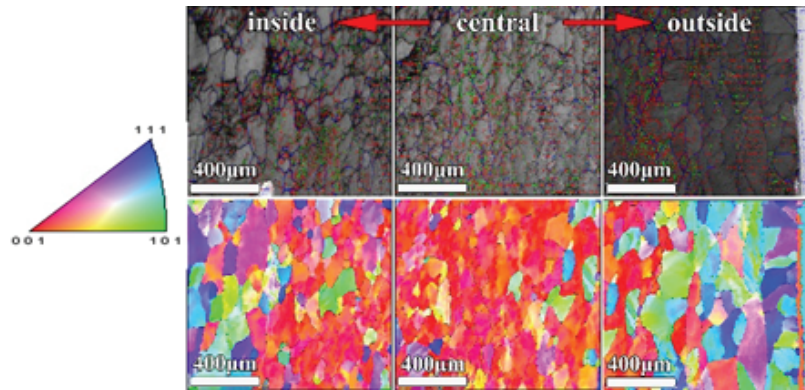
The present study shows that the differences in crystal orientation within a polycrystalline material produce variations in the local yield criteria [9]. The grain rotations by in-situ EBSD measurements have been reported, which allowed studying the amount of rotation and the rotation path of the selected grains. However, the investigation of the changes during tube hydroforming by using in-situ analysis technique presents difficulties. Based on the presented analysis, it is shown that the grain morphology at the surface and its variation along thickness direction, allowing extracting the grain orientation rotation behavior along the tensile load axis, so similar to the data obtained by the in-situ method, can be investigated by the considered method. The grain boundary and orientation maps in the thickness direction are shown in Fig. 7. The pronounced variation of the grain orientation and boundary morphology, which is consistent with the morphology shown in Fig. 6, is observed. In the central area, the grains exhibit low angle boundaries with the angles $<15^\circ$. However, in the outside and inside areas, part of coarse grains exhibit low misorientation, which indicated that appreciable changes in the local orientation occurred in those grains. At the same time, there still remain a number of the coarse grains with the high angle boundaries. As can be seen from the crystal orientation map, the orientation of central grains demonstrated strong tendency toward $\langle 001 \rangle$ orientation, while the layer of 1~4 grains still remains at random orientation. In the inside and outside areas the grains possess low angle boundaries. This can be compared with the grain behavior in the concave areas shown in Fig. 4b. The grain orientation rotation in the central areas inevitably affect the surface grains morphology.

Figure 7: Crystal orientation (top) and grain boundary (bottom) maps in the thickness direction (after tube hydroforming).

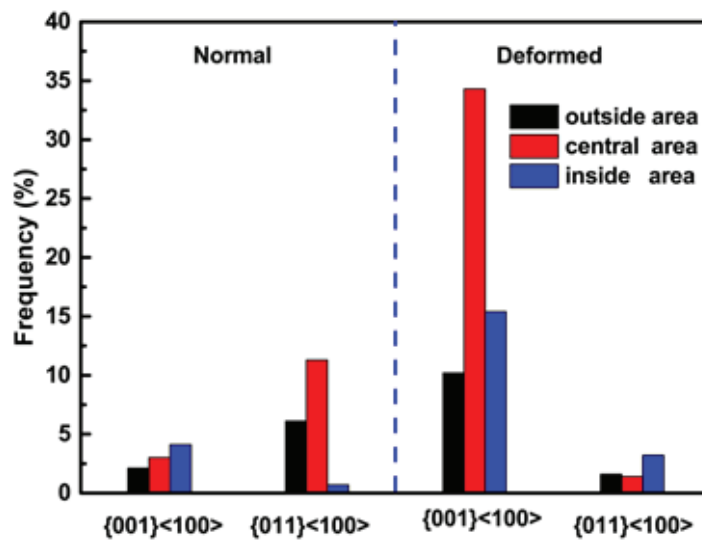
Fig. 8 shows the fraction of the texture in the three areas along the thickness direction before and after tube hydroforming, which corresponds to results shown in Figs. 6 and 7. In all the three areas only $[001]\langle 100 \rangle$ Cube and $\{011\}\langle 100 \rangle$ Goss texture components were obtained. It is shown that the volume fraction of the $\{001\}\langle 100 \rangle$ Cube texture component significantly increases in the three areas, especially in the central area ($\sim 35\%$). In contrast, the volume fraction of the $\{011\}\langle 100 \rangle$ Goss decreases in the outside and central areas, but increases slightly in the inside area. This increase of

Figure 8: The volume fractions of the texture components in the thickness direction before and after deformation.

volume fraction of the Cube texture occurs, because some grains rotated away from their original orientations, which can cause the rotation of the grains in the marginal areas (inside and outside).
