Conference Paper

Proposed Testing Quality of Silicon Nitride in Nuclear Application by Ceramography

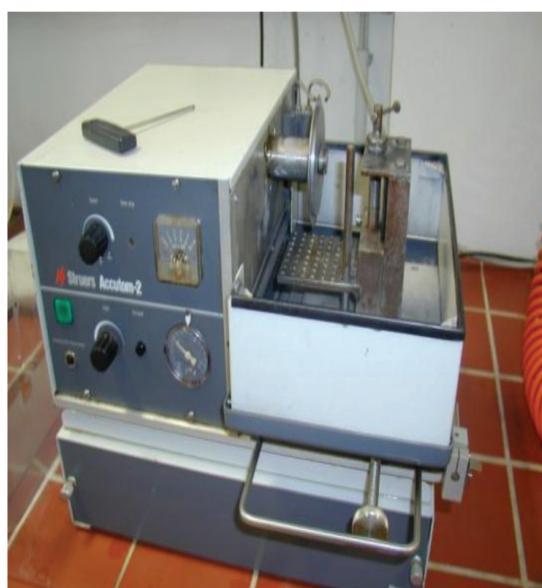
Figure 1: Diamond wheel machine.

The material use for this research was Si_3N_4 produced by CeramTec (Plochingen, Germany) under the name SL200 B. It is a gas pressure sintered ceramic containing 3 wt.% Al_2O_3 and 3 wt.% Y_2O_3 . The material was cut by using diamond wheel (Fig. 1) with about the same thickness and mounted at upper disc of polishing machine (Fig. 2) by using thermoplastic glue (Fig. 3). For this purpose the disc should be heated by using hot plate in order to melt the glue.

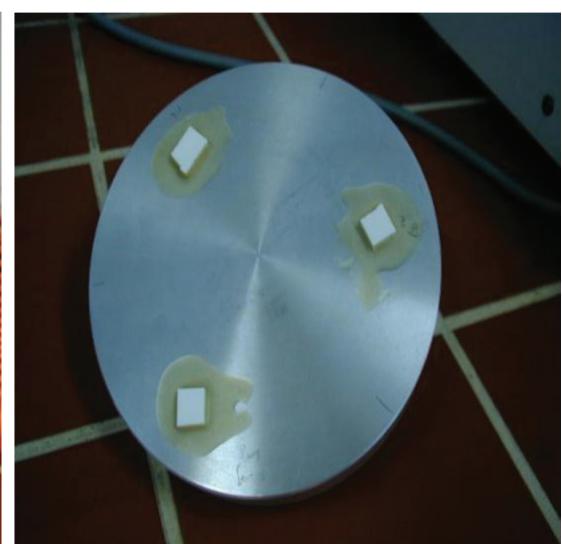
Figure 2: Mounting the specimen on upper disc of the polishing plate.

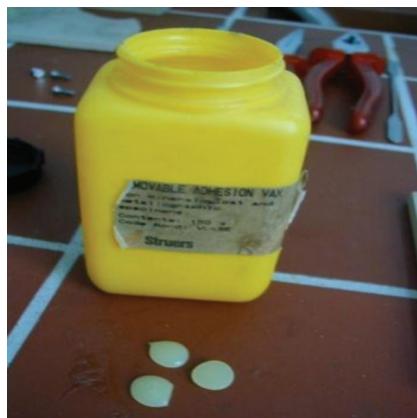
Figure 3: Example Commercial thermoplastic type of glue.

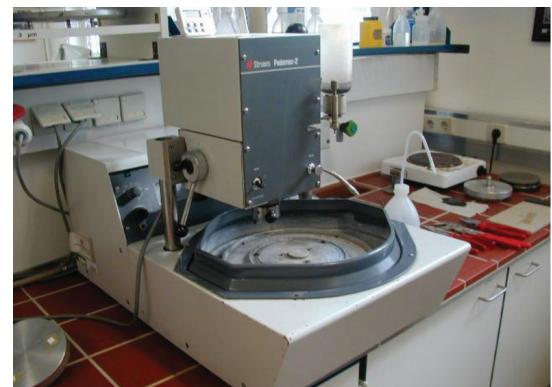
Figure 4: The polishing machine for ceramography. It is completed with upper and bottom disc to provide pressure during grinding and polishing.

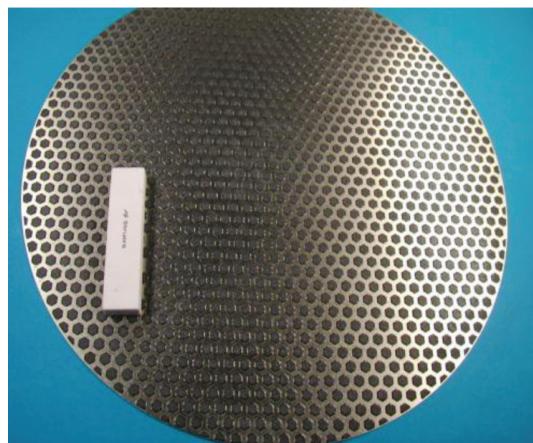
Figure 5: The piano type of diamond grinding.

The polishing was started with piano type of diamond grinding disc (Fig. 5), followed by serial polishing by using diamond powder (Fig. 6) with time and pressure variable listed in Table 1.

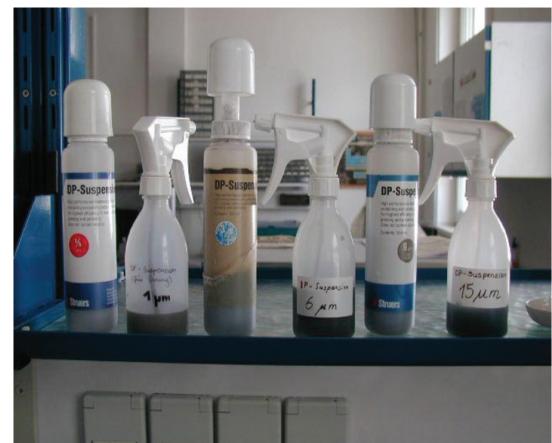
Figure 6: Serial of diamond powder for polishing.

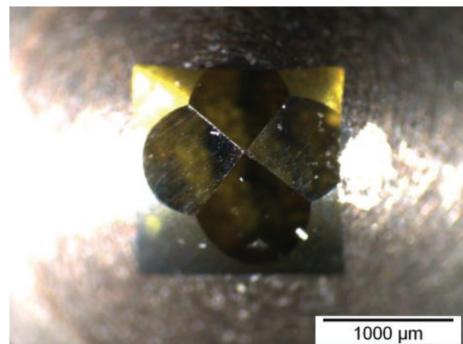
Figure 7: Vickers indenter.

Bright field and differential interference contrast (DIC) or so called Nomarski in optical microscope is used to observe whether the final surface still contain scratch or not. Indentation test then was performed by using Vickers (Fig. 7) and Knoop (Fig. 8) indentation. By using Vickers, the value of hardness and fracture toughness and can be provided, and from Knoop indentation the value of modulus elasticity will be obtained.

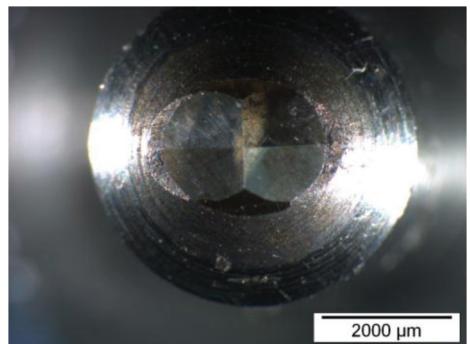
Figure 8: Knoop indenter.

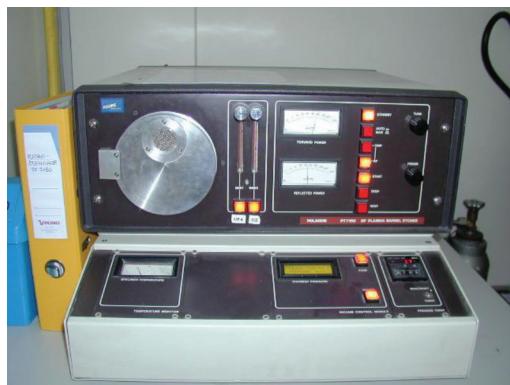
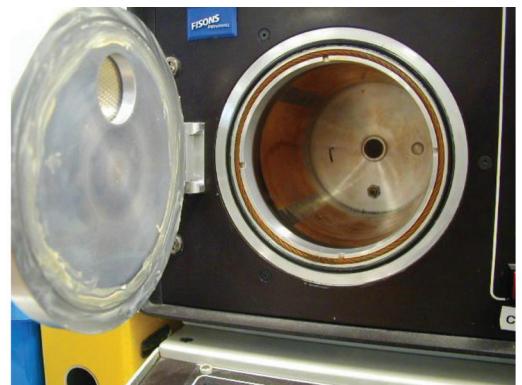
Figure 7: (a) Equipment for plasma etching, (b) Detail chamber for plasma etching.

Since Si_3N_4 is ceramic material, this is meaning that etching process is difficult to be performed by using chemical solution. Plasma etching (Fig. 9) was introduced in this research to reveal the microstructure. Microstructure then was revealed by using both optical microscope and scanning electron microscope (SEM). This report will be completed with successful technique in revealing the defect such as crack and porosity by utilizing fluorescence dye penetrant with ultra violet (UV) source of light.

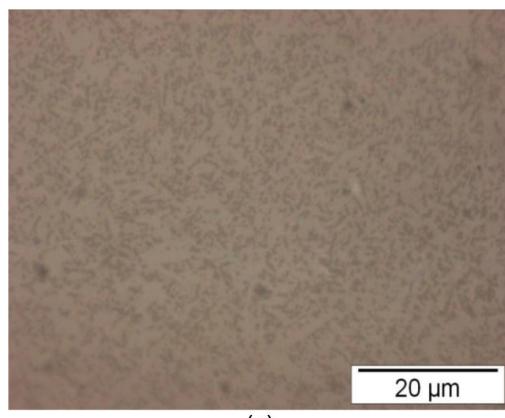
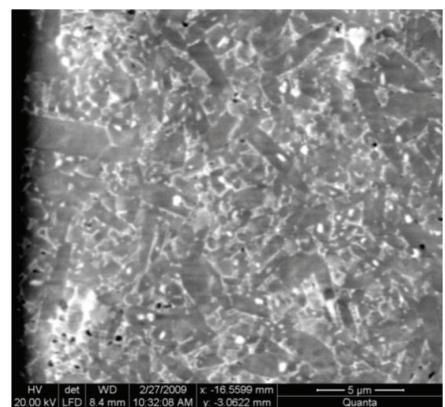
Figure 8: Microstructure after plasma etching of Si_3N_4 (a). By using optical microscope. (b) Obtained from SEM.

The grinding and polishing step that was developed in this research is successfully to obtain smooth surface without scratch. The microstructure that is found as can be seen in Fig. 8. Both optical and SEM picture are presented, and indicated that there are elongated grain as a typical of $\beta \text{Si}_3\text{N}_4$ [3].

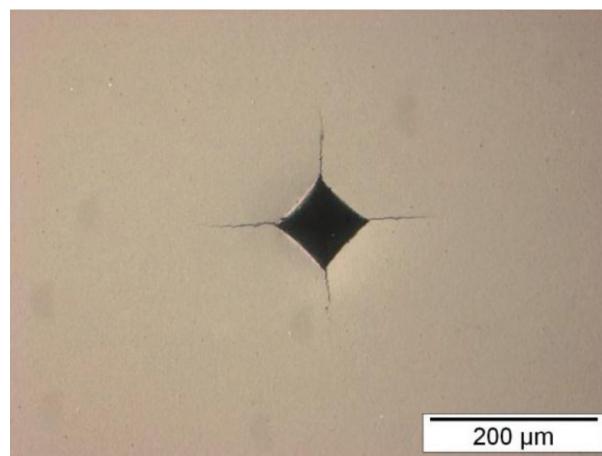
Figure 9: Vickers indentation of Si_3N_4 , load applied was 10 kg.

The Vickers hardness value was investigated based on ISO TC 206/SC N [4]. The load F that was applied was 10 kg. The Vickers indentation was found valid as depicted in Fig. 9, with values found was 14.2 GPa HV10, calculated by using Equation (1)[4] with d is the arithmetic mean of two diagonal Vickers indentation.

$$\text{HV(GPa)} = 0.001 \frac{2F \sin \frac{136^\circ}{2}}{d^2} = 0.001854 \frac{F}{d^2} \quad (1)$$

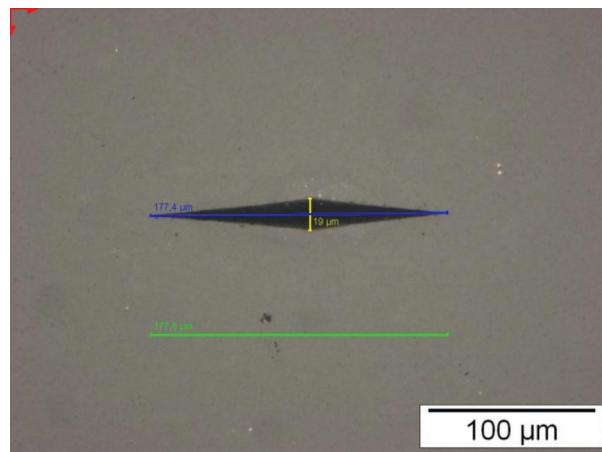
Figure 10: Measurement of long and short diagonal of Knoop indentation (HK 3) for modulus elasticity measurement.

With value of b'/a' that was obtained from Knoop indentation as depicted in Fig. 10. The value of E that is calculated from Equation (3) was obtained 189.2 GPa.

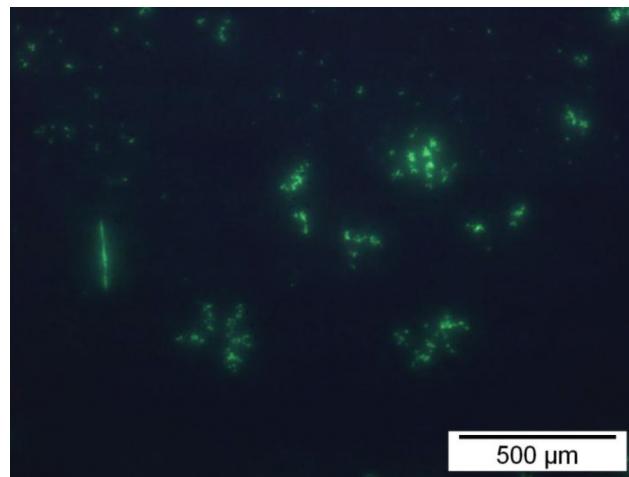
Figure 11: Illuminated green color is the defect in the specimen. This is obtained by immersed the specimen in the fluorescence dye penetrant. Observation was done with optical microscope under ultra violet source of light.

The defect in the specimen was easily detected by using fluorescence dye penetrant as depicted in Fig. 11. Ultra violet source of light was applied for this purpose.
