Control Quality of Welded Joints by Scanning Contact Potentiometry Method

Conducted evaluation of technical state of welded joints, welding the collectors of the primary loop to the body of the sample of steam generator PGV 1000, located in Resource center National Research Nuclear University MEPhI at "AEM-Technologies" Atom mash factory in Volgodonsk. The results of point-by-point scan shows that SLS 1000 μV and above, for almost all samples detected multiple superficial imperfections caused by the presence of certain rust spots and traces of a deep spot corrosion, and the presence of small nicks, scratches and other imperfections.

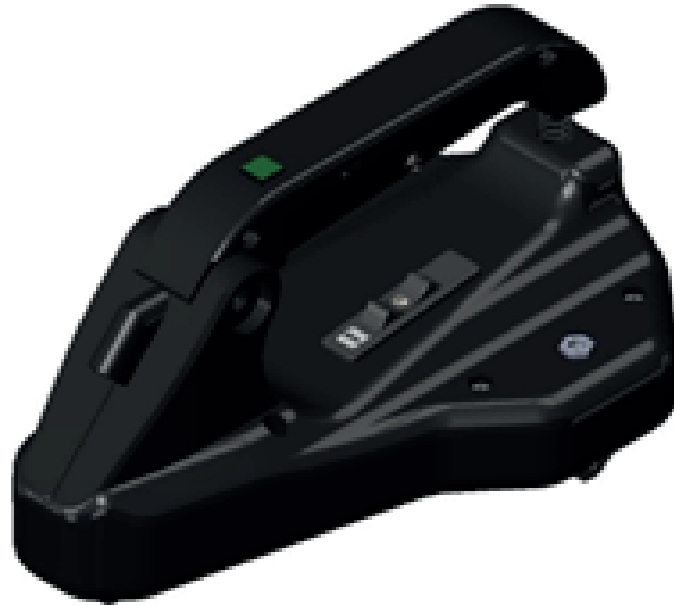
Figure 2: Electro-physical flaw detector (defectoscope), EDSS - 1RD [5].

By SCP Method, in the area of monitoring was carried out point-by-point measurements using a portable probe and EF-sensor, and then carried out the surface scan by manual electro-physical flaw detector(defectoscope), EDSS - 1RD (Figure 2).

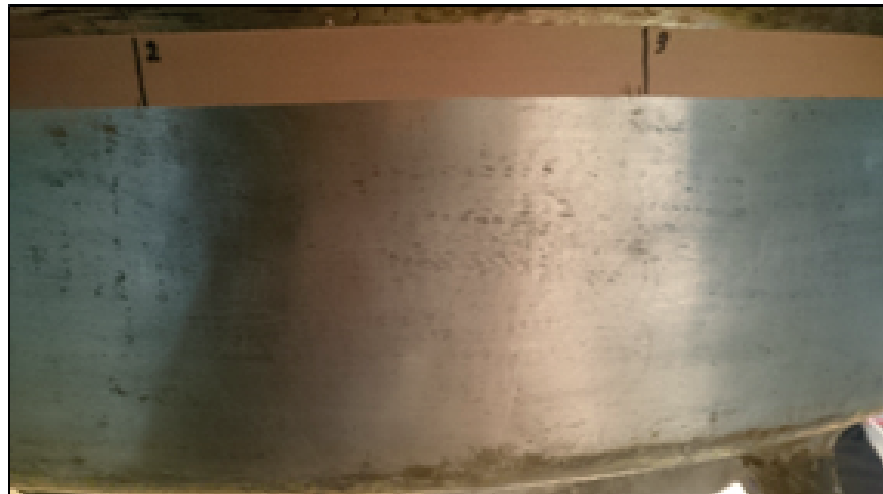
Figure 3: Fragment of the welding node of the cold collector of the sample of the steam generator with the welded joint.

The band location of the surface defects of the welding joint of the sample of the steam generator is carried out. The fragment of the welding joint of the cold collector of the sample of the steam generator with the welded connection located on it is shown in (Figure 3) and (Figure 4.a) the inhomogeneous distribution of potentials on the surface of the welding joint is shown. Measuring sections along the x-axis, number of tracks along the y axis. The inhomogeneities are distributed mainly in the upper and central parts of the welding joint.
