Conference Paper

The Importance of the Directives Creation for the Evaluation of the Buildings Envelope Conditions in Condominium Regime Inserted in a Technical Management Model

Vitorino Neves and João Lanzinha

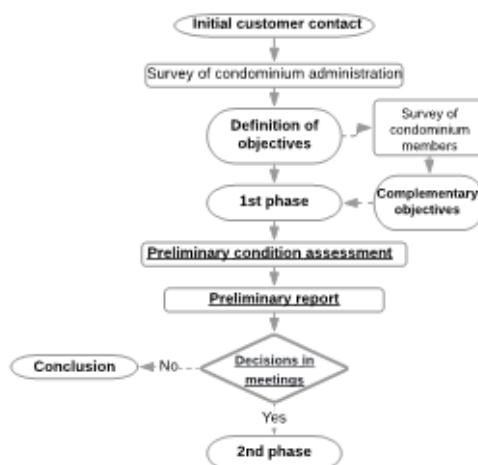
Figure 1: Organizational chart of the methodology of assessment of the envelope of current condominium buildings (preliminary assessment).

In general, the procedures described above explain the assessment of the conditions of the envelope as shown schematically in Figures 1 and 2 below.

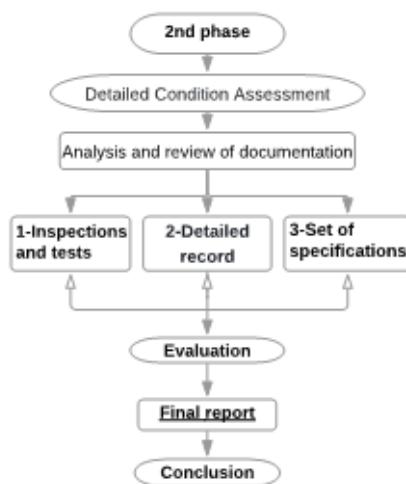
Figure 2: Organizational chart of the methodology of assessment of the envelope of current condominium buildings (detailed assessment).

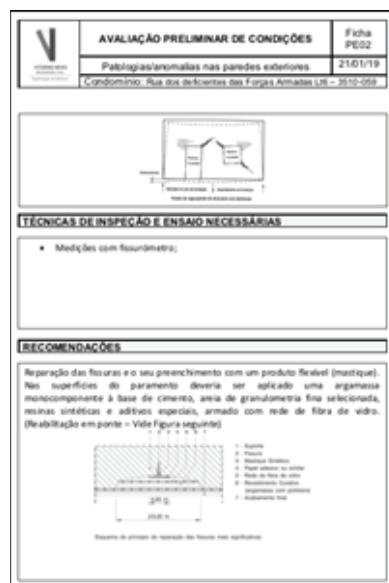
Figure 4: Constituent part of the pathology file used in the report.

In the observations of pathologies/anomalies in the interiors of the common fractions/zones and external elements, the forms created for this purpose were completed. In the records of the external elements, the pathology was named and recorded, photographic images were shown, with the following order of visualization - Surrounding area; Location; Detail of the pathology - description of the pathology, the probable

causes for its appearance, necessary inspection and testing techniques, recommendations for rehabilitation actions and scales of level of severity and urgency of intervention.

A copy of a pathology file is shown in Figure 4.

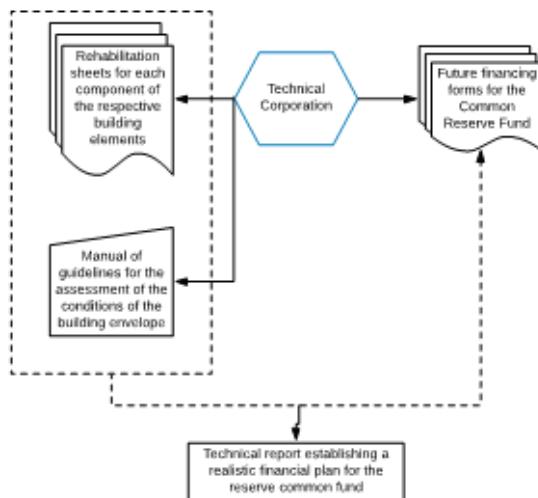
Figure 5: Organisation chart of the methodology for creating a technical management model for condominiums.

In Figure 5 it is schematized, in a simplified way, what is intended to be made.
