Conference Paper

Hausmannian Buildings Rehabilitation and Strengthening

Abstract

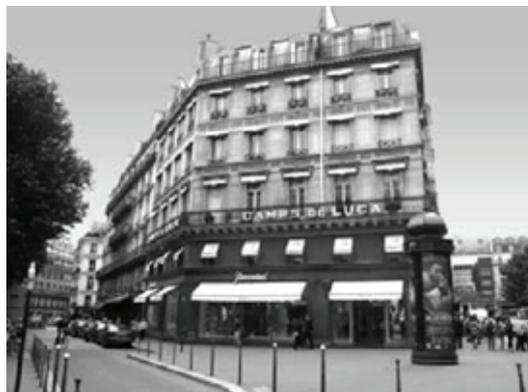
Figure 1: The Hausmannian building, La Madeleine near the Saint Marie Madeleine Church

Hausmannian building were built between 1830 and 1841. These buildings have usually 6 or 7 stories. Site observations allowed to conclude that their structure is highly composite and conceived essentially with local materials, [16]. The main façades are made with 55cm width dressed stone Fig. 1.

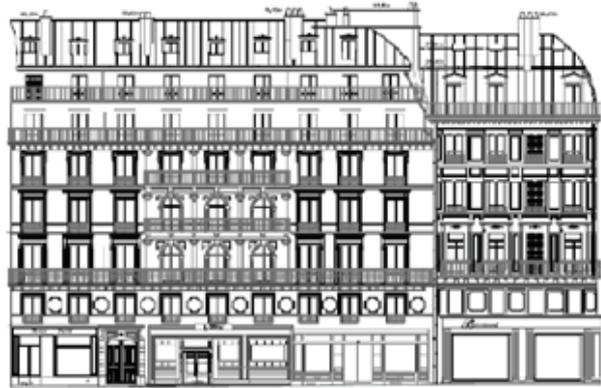
Figure 2: The Hausmannian building, front façade

The façades located in the backside are made with a timber frame structure filled with limestone rubble or with a steel frame structure filled with bricks. The ground floor might have a commercial use and the basement floor is used as a storage and to the technical equipment. The uppers floors are used for office purposes or housing, Fig.

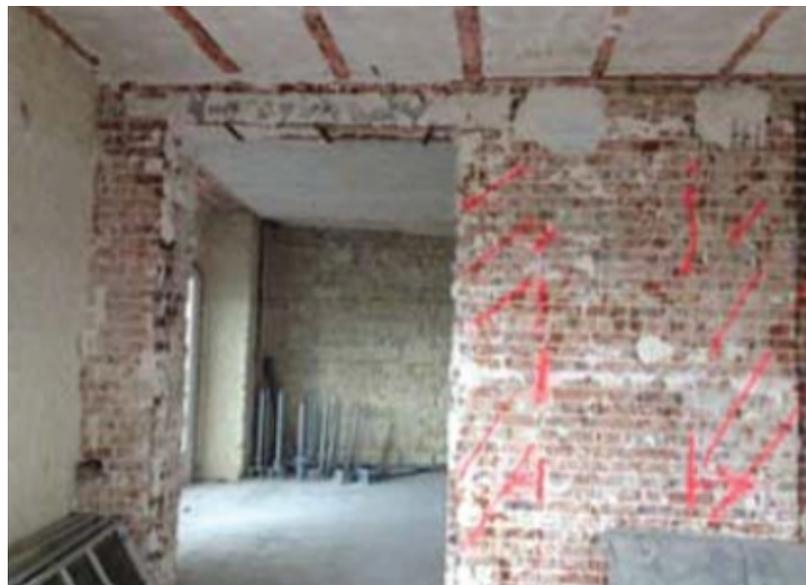
Figure 3: Interior walls, clay brick wall

2. The interior walls are made with clay bricks, Fig. 3 or a timber structure filled with limestone, Fig. 4, both of them usually load-bearing walls.

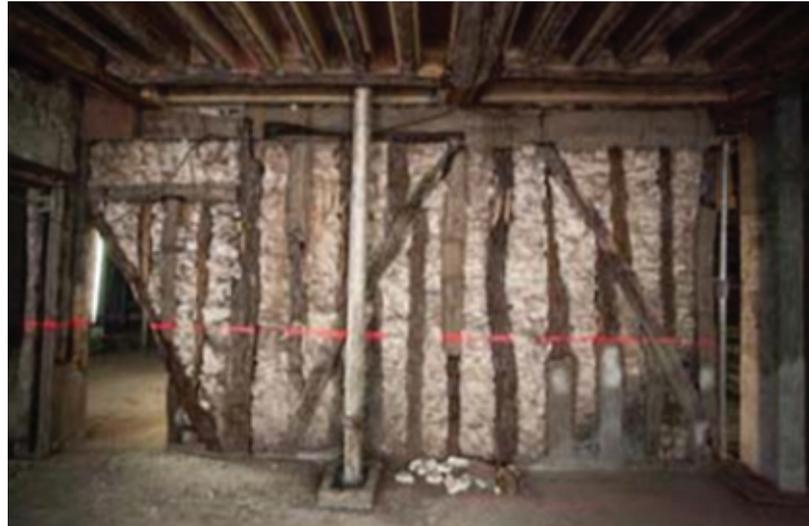
Figure 4: Interior walls, timber wall

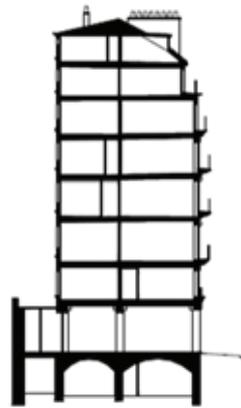
Figure 5: Hausmannian buildings structure, building cross-section elevation

Generally, the façade walls of two upper floors are also made with a timber frame solution, Fig. 5. On the ground floor level, the façades are supported by limestone rubble masonry walls located beneath them, on the basement floor and along the building perimeter, [17]. The ground-floor is supported with limestone masonry vaults and the vaults are supported by interior and perimeter limestone rubble masonry walls, Fig. 6.

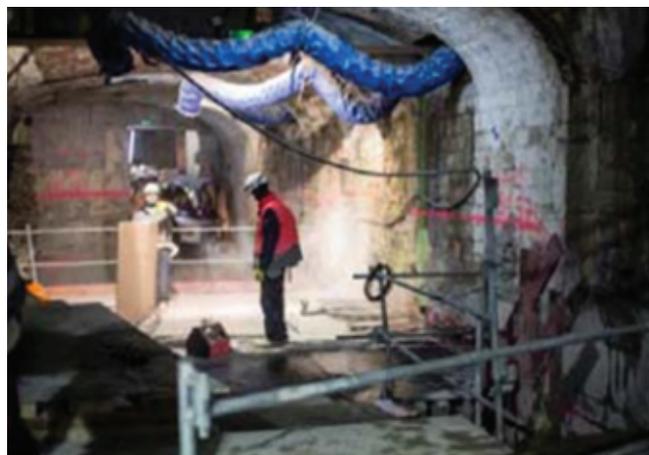
Figure 6: Hausmannian buildings structure, basement walls.

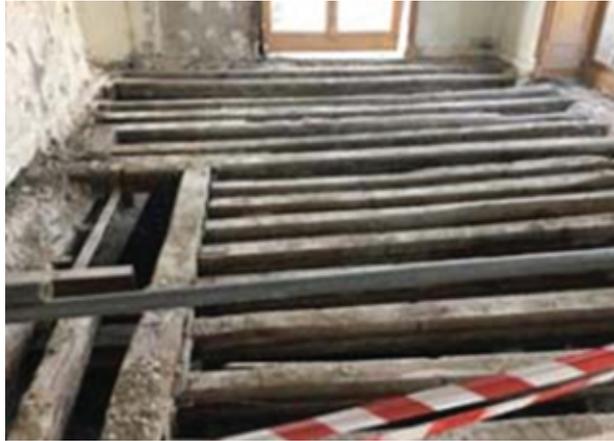
Figure 7: Timber floors,

The timber floor structure is made with massif oak timber beams made, under these beams laths and a mortar bears the floorboard revetment, Fig. 7, below theme and attached to it, there is the floor ceiling made with laths and plaster as shown in Fig 8, [18].

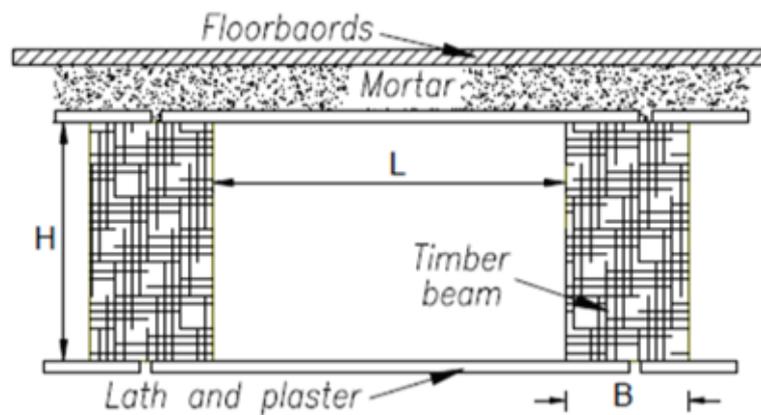
Figure 8: Timber floors, detail

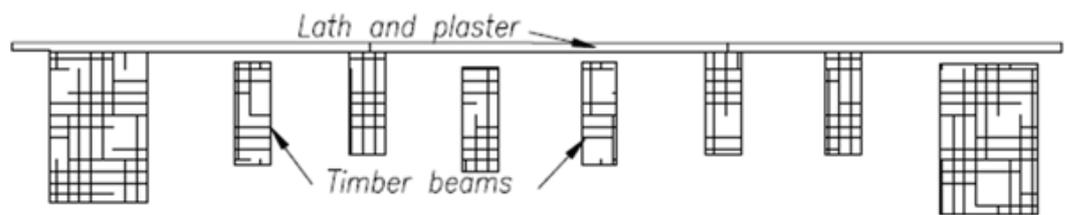
Figure 9: Timber floor - Initial state

floors do not have the necessary load carrying capacity, but also because regarding the overall building stability they do not brace correctly the structure against possible horizontal movements of the façade. The strengthening work consists in pouring a new concrete slab under the existing timber beams. The connected concrete slab is usually 8 cm thick. The initial state of the timber pavement is illustrated in Fig. 9 and represented by the existing timber beams, the laths and the plaster.

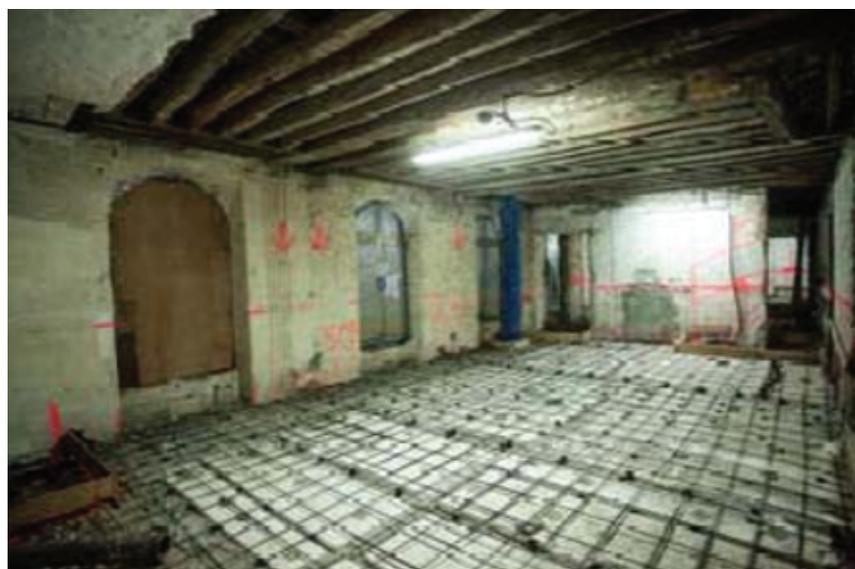
Figure 10: Strengthened timber floor, connectors and reinforcement

Steel cylinders made connectors are applied on the top of the beams, their spacing and number are obtained after calculations, Fig. 10, then the reinforcement is put in place and finally the slab is poured, Fig. 11. Fig. 10. clearly shows that this technique allowed to maintain an important quantity of existing materials and therefore it can be classified as a sustainable strengthening technique. This will not have been the case, if instead, a complete 20-25 cm thickness traditional concrete slab should had been poured.

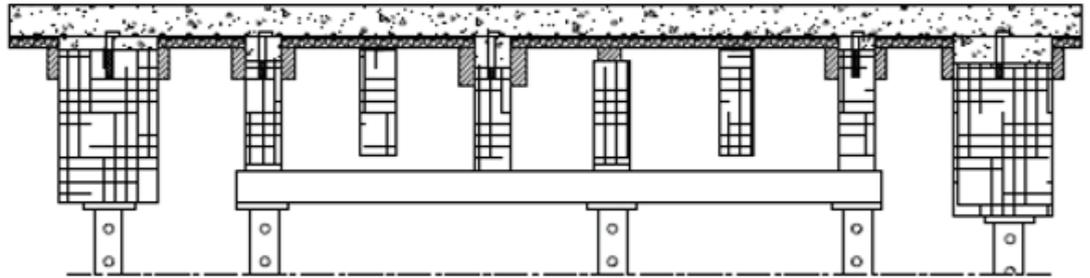
Figure 11: Strengthened timber floor, connected concrete slab

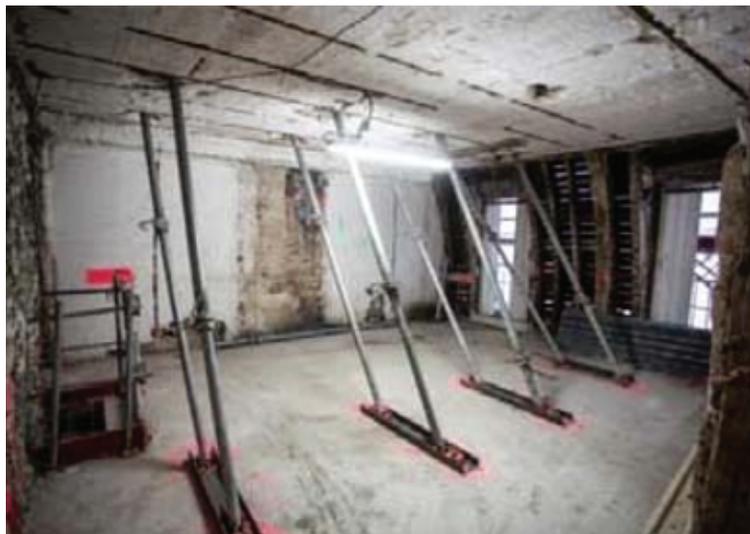
Figure 12: Metallic IAO floors

In Hausmannian buildings, it is usual to find floors made of metallic beams constituted of IAO cross-sections, Fig. 12. Between these beams, plaster interjoist elements are set, Fig. 13. The investigation on metallic IAO profiles indicated high deflections and plaster cover deterioration. Furthermore, the design calculations indicate also that these floors do not have the necessary strength to carry the loads rising from the new regulations, [20] and due to use changes operated.

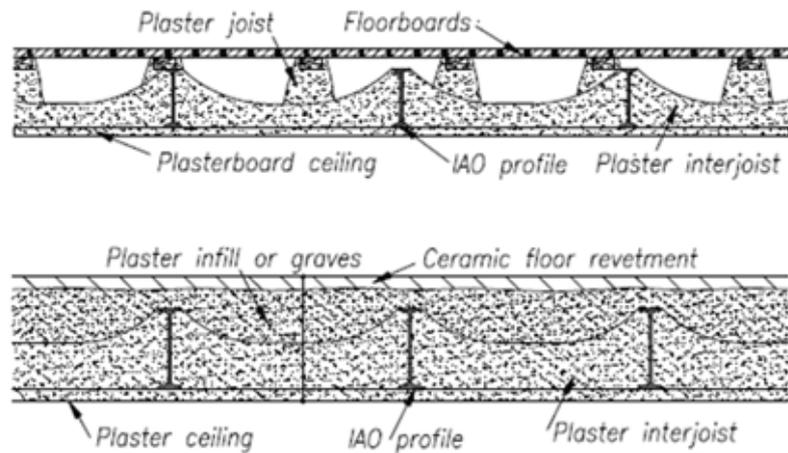
Figure 13: Metallic IAO floors, detail

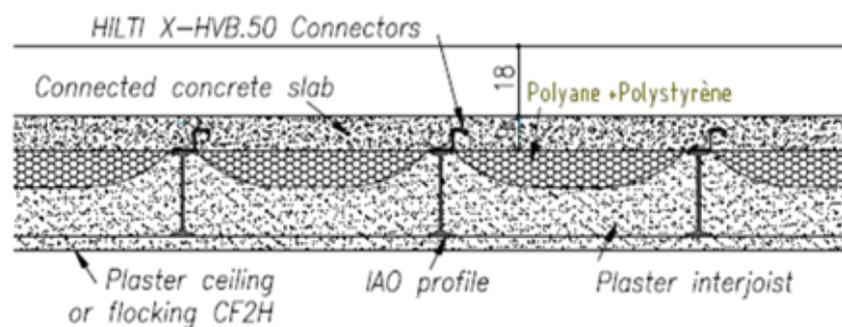
Figure 14: Connected concrete slab

Investigation on the metallic IAO profiles allowed identifying different types of metallic floors, depending on the IAO dimensions, [18]. The strengthening technique for the existing metallic floors consists in maintaining the IAO profiles and creating a new concrete slab. Three solutions can be considered, in the first a concrete slab is connected to the metallic IAO profiles, the existing plaster interjoists are kept in place, Fig. 14 illustrates this solution. The connected concrete slab thickness can vary between 8 and 12 cm. Hilti X-HVB steel connectors are connected to the top of the IAO profiles.

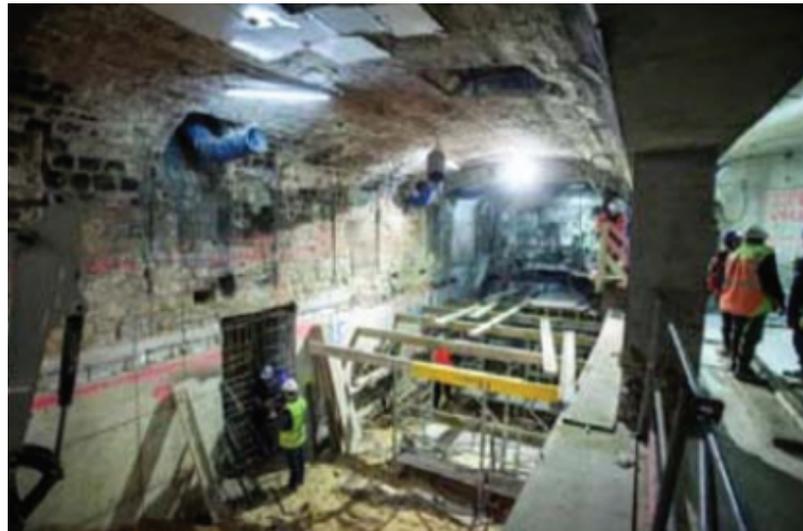
Figure 15: Basement concrete raft pouring, existing basement

Hausmannian buildings usually have only one basement, presently it is usual to increase the existing basement head height or to add one or two basement floors. One of the most commonly used techniques in Hausmannian buildings to underpin the existing foundations is concrete pouring. This technique consists in excavating the soil under the existing foundation and pouring concrete to construct a new wall and its foundation at the desired lower level, [21]. Fig. 15 illustrates the underpinning works relative to the addition of a basement floor and Fig. 16 represents the construction drawing, [22].

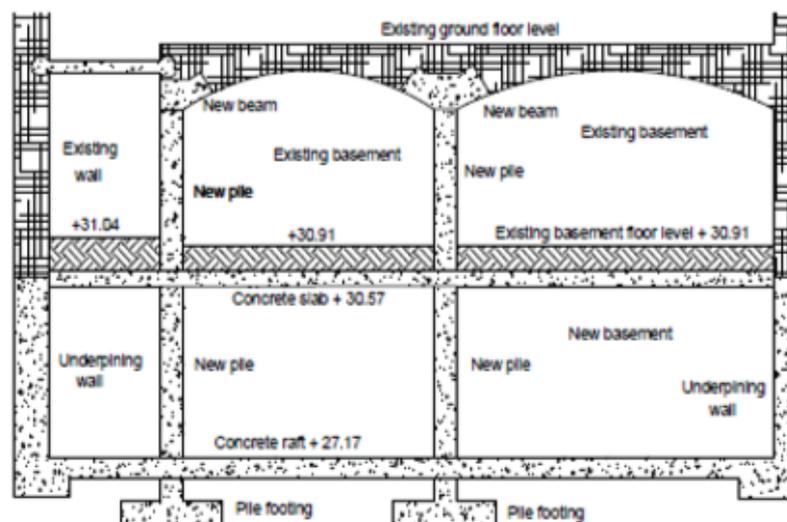
Figure 16: Basement concrete raft pouring, new basement design

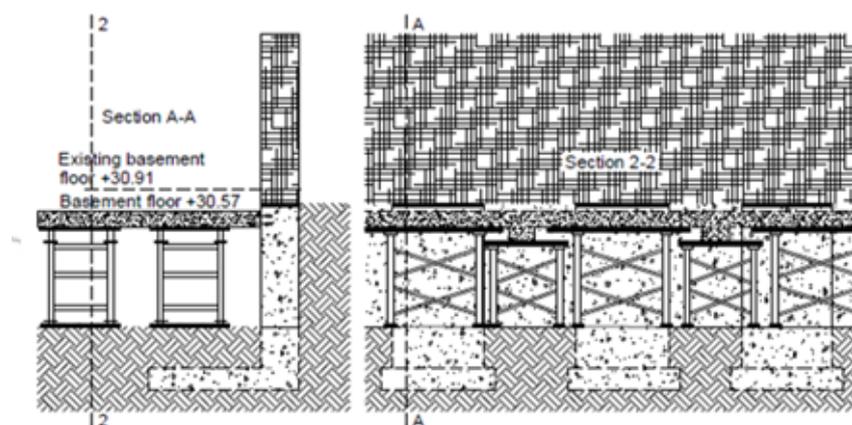
Figure 17: Floor basement pouring, slab concrete pouring

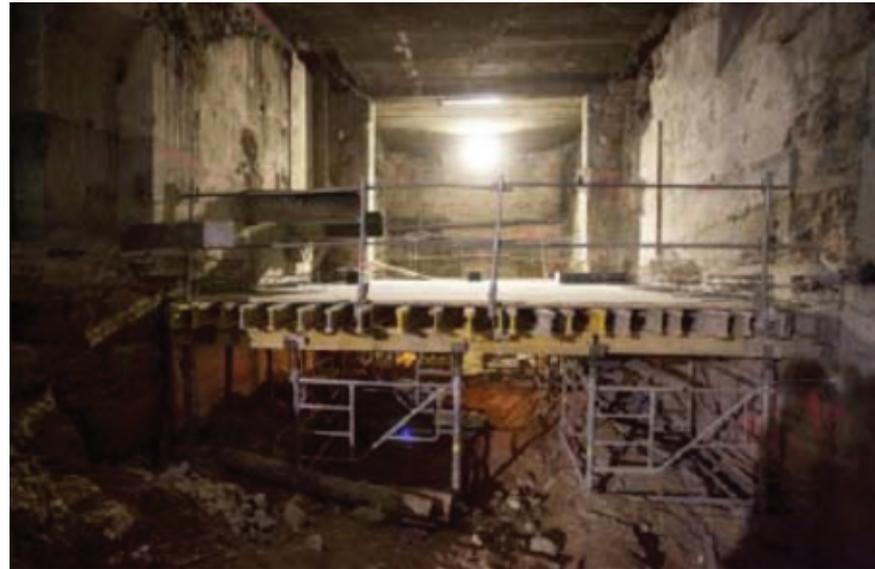
Figure 18: Floor basement pouring, slab shoring tower

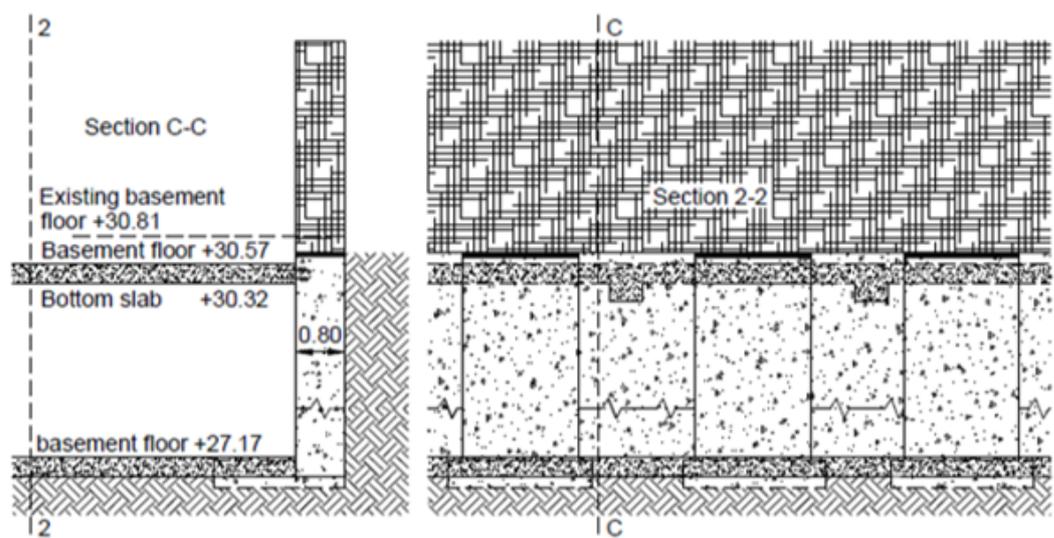
Figure 19: Basement concrete raft pouring

Fig. 19 represents the construction drawing relative to the pouring of a concrete wall beneath the existing limestone rubble masonry wall, the new concrete floor and the concrete raft.

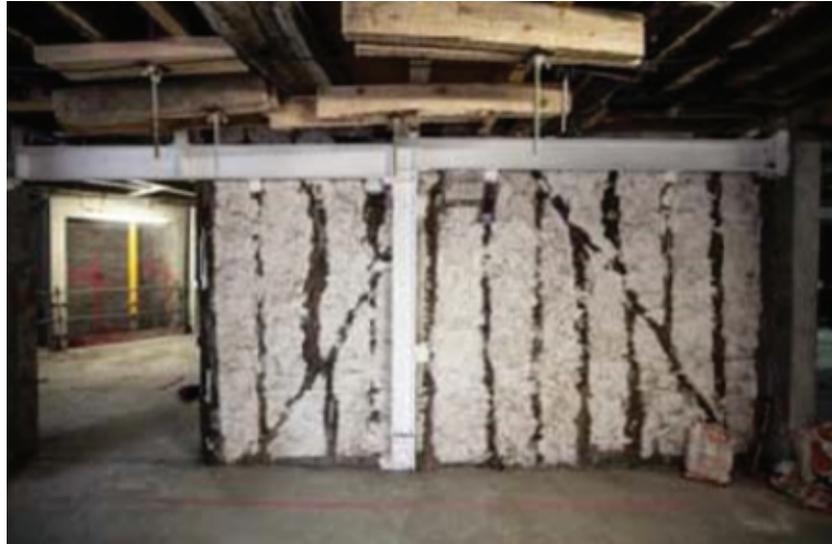
Figure 20: Timber walls rehabilitation, wall strengthening

The interior walls, made from a timber structure or made from masonry bricks are usually removed, for partition reasons, otherwise they are kept in place. In Fig. 20 a timber wall

is kept in place but strengthened with a steel portal frame. In Fig. 21 a timber structure was removed and replaced by a concrete frame with beams and columns.

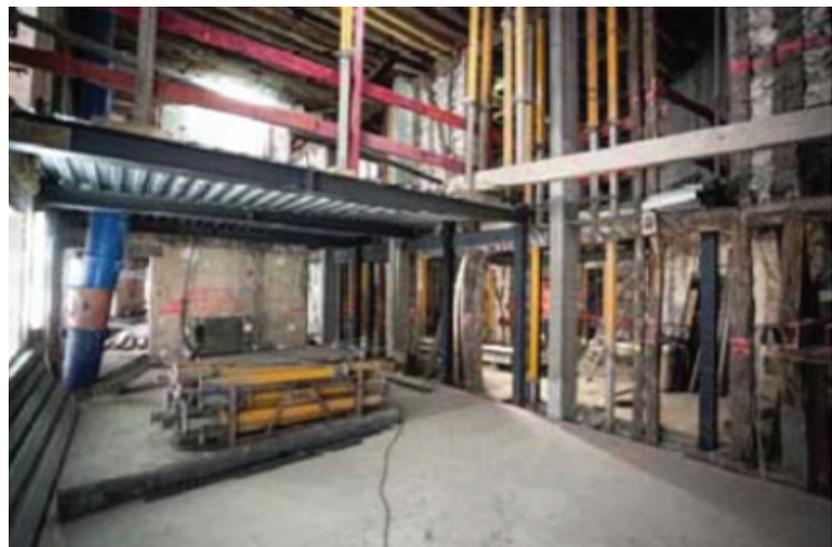
Figure 21: Timber walls rehabilitation, wall removed

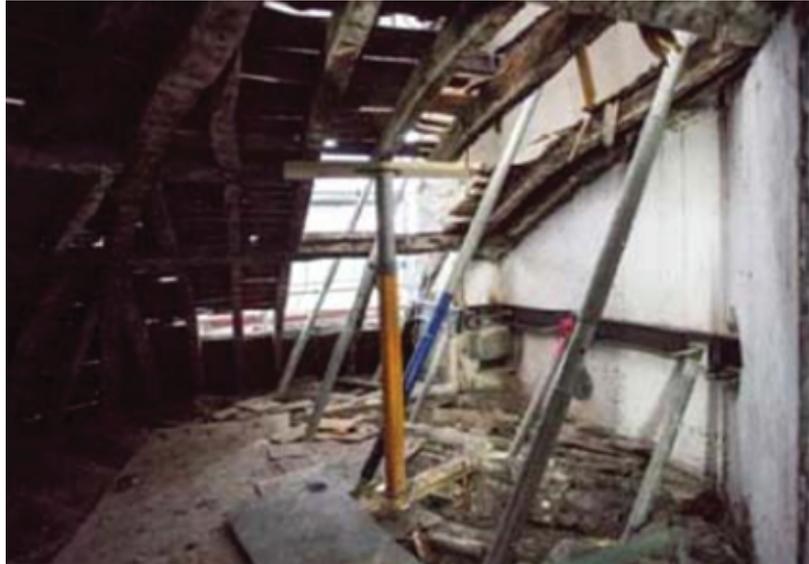
Figure 22: Existing timber roof structure

The roof structure, made with timber components, is another component that is usually subjected to rehabilitation and strengthening works, since the original structure usually presents an accelerated decay due to water penetration, among others, Fig. 22.

and just after his removal. In Fig. 22 it is also possible to observe that the chimneys, braced by the roof had to be correctly shored with props to withstand the wing action. As stated previously, one possible way to rehabilitate the roof structure consists in the erection of a new timber structure as represented in Fig. 24 Fig. 25 illustrates a view from the inside of the timber structure.

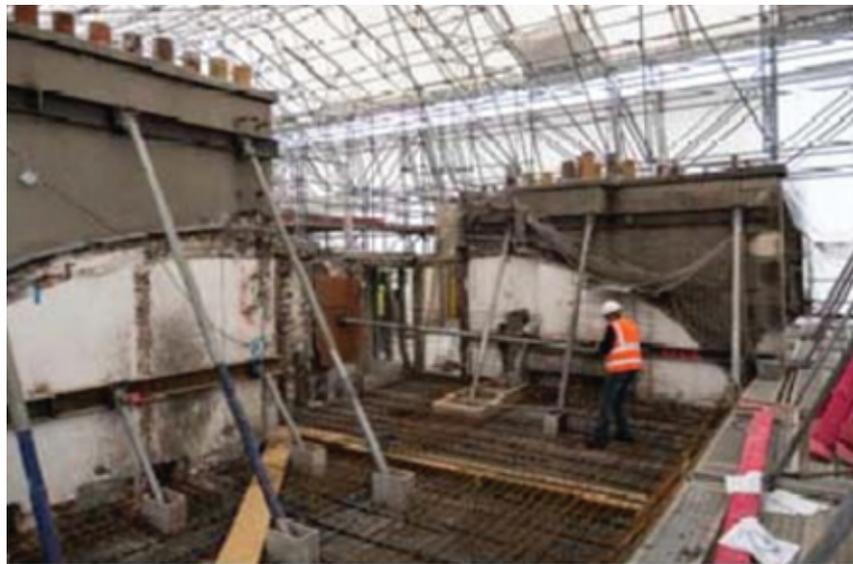
Figure 23: Existing timber roof structure, removal

The existing timber structure is replaced by a new timber structure or by a steel structure. In Fig. 23 it is possible to observe the attic without the roof timber structure

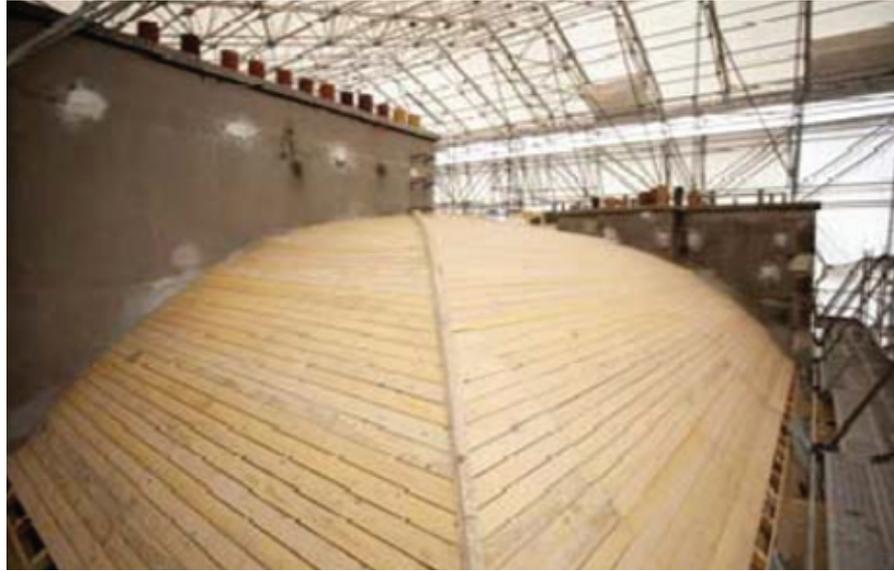
Figure 24: Roof rehabilitation, new roof timber structure

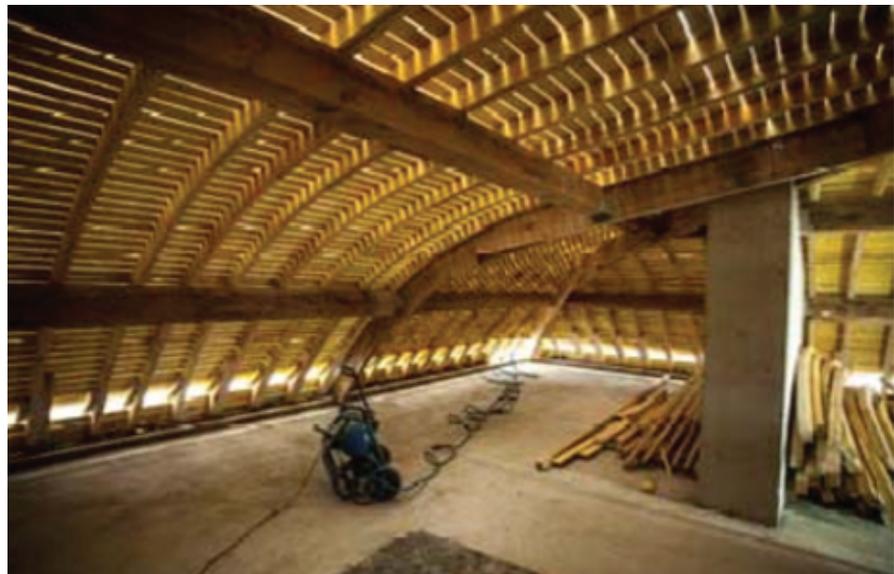
Figure 25: Roof rehabilitation, inside view

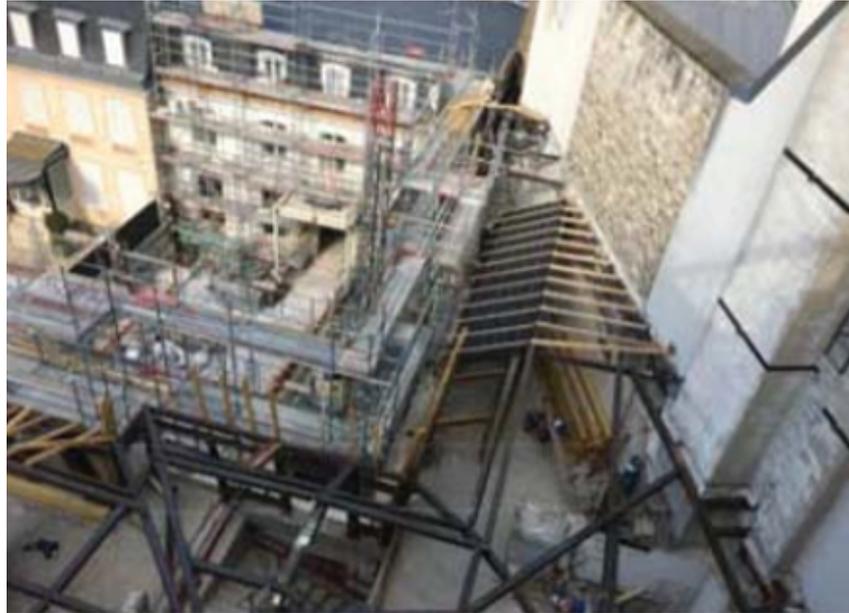
Figure 26: Roof rehabilitation, roof structure erection

Another possibility to rehabilitate the roof structure consists in the erection of a new structure made of steel profiles as represented in Fig. 26 and Fig. 27.

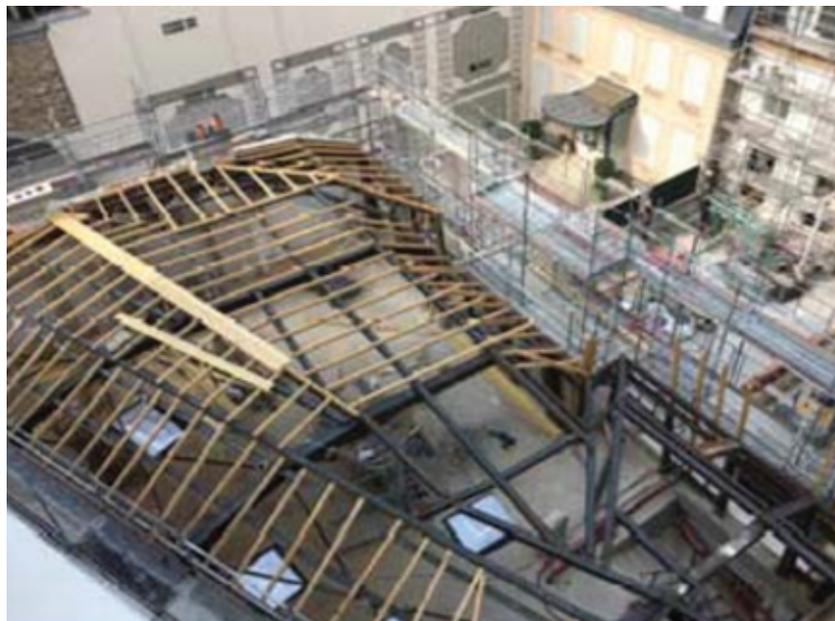
Figure 27: Roof rehabilitation, roof timber components
