Conference Paper

Physical Environmental Assessment of 'Colorful Village' on the Banks of the Code River, Yogyakarta

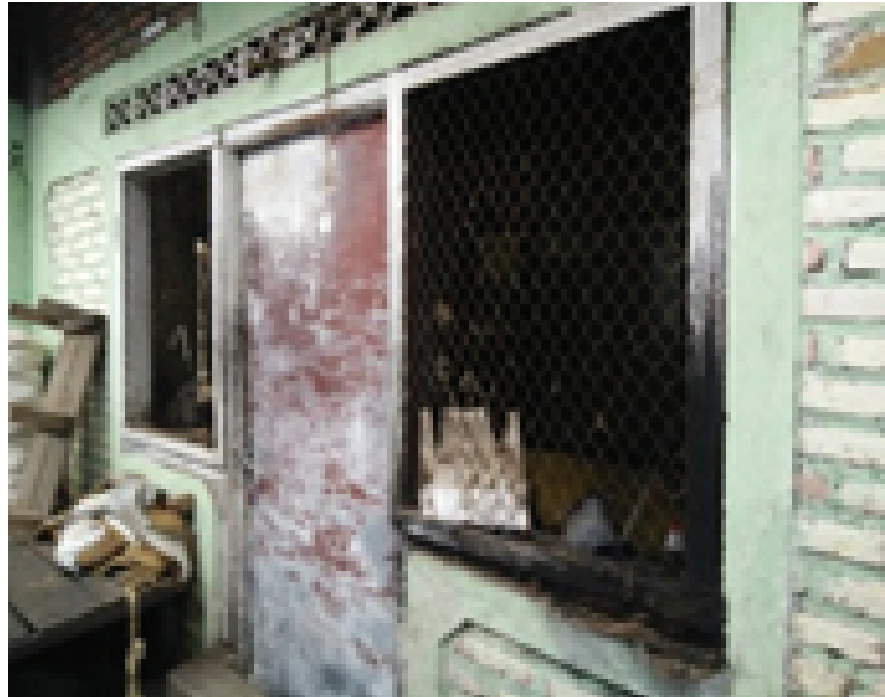
From results, there are 148 units or 61 percent of residential buildings that do not have regularity building according to requirements. Buildings located on the banks of the river appear to have been reconditioned to have a direction towards the river, while for buildings in the village it still seems irregular. Building density of 23% is deemed acceptable. Approximately 100 units or 41 percent of quality residential buildings are

Figure 1: Picture of buildings condition. (Source: Author's collection.)

deemed not to meet technical requirements. Most houses are dark even during the day because the condition of the adjacent buildings prevents sunlight from entering. The majority of house buildings appear to have been painted in bright paint colors, however, the use of decorative paint in buildings that were not well maintained, over time, turned out to produce a lot of peeling paint. The peeling paint is also dangerous to health if swallowed by children. This discussion is supported by the following references [12–16].

Recommendations, the government needs to plan housing arrangements, improve the quality of roads, and build infiltration wells, as well as improve fire protection infrastructure following the requirements. Regarding the use of paint, it is included as an arrangement for building materials on quality criteria, were based on the requirements it is necessary to pay attention to the impact on the environment and need to pay attention to the health and comfort of the occupants.

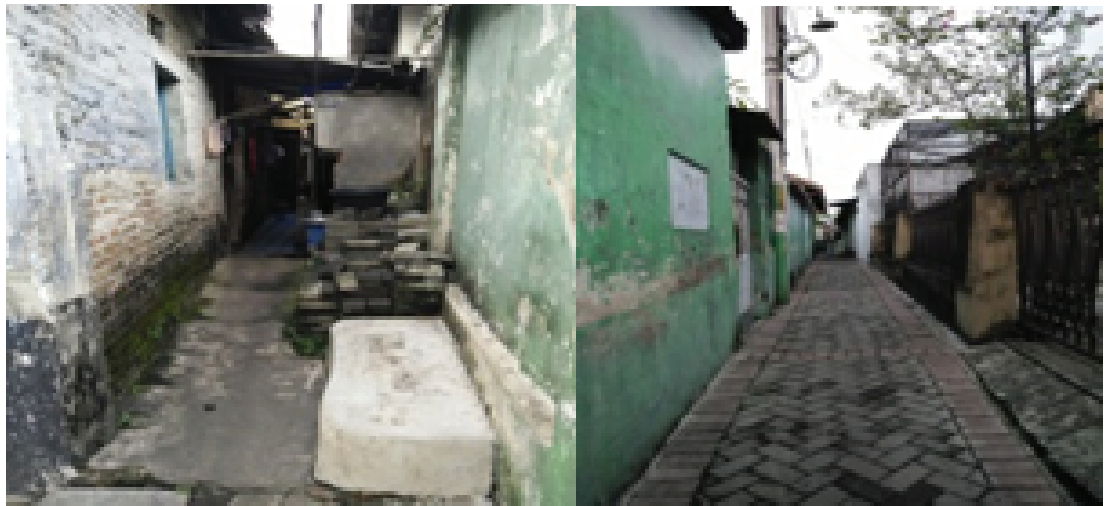
Figure 2: Pictures of infrastructures condition. (Source: Author's own collection.)

In infrastructure for accessibility, some road conditions have poor quality surfaces. There is no separation between residential buildings and roads, such as sidewalks. A small portion of the road has been improved surface quality using paving blocks, but most of the roads on hamlet 05 and hamlet 06 are still not repaired. In infrastructure for drainage, although it is considered zero percent free from puddle, there is still damage

to the physical infrastructure even though it is minimal. Based on brief interviews with residents, sometimes when it rains, floods still occur. This situation requires further investigation. The construction of drainage infrastructure is deemed necessary in hamlet 06. As for infrastructure for drinking water in the form of water pipelines or non-piped water networks, only 36 percent are deemed feasible. In infrastructure for wastewater, it was found that the majority of residential buildings did not meet the complete technical requirements for sewage whereas the infrastructure for solid waste is already good because there is zero percent of domestic waste that is transported to final disposal less than twice per week, which means that it meets technical requirements. In infrastructure for fire protection, most of the road width in residential areas is narrower than the technical requirements for fire protection, which is 3.5 m. The environment with a narrow circulation cannot be traversed by fire trucks, so if a fire occurs it will be difficult to overcome. This discussion is supported by the following references [13–15, 17, 18].
