Traditional Ship Stability Evaluation in Toba Lake

Abdy Kurniawan and Wilmar Jonris Siahaan

Abstract

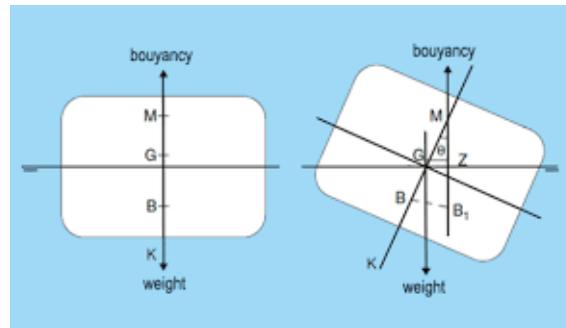
Figure 1: Ship stability graph (Source: IMO, 2002)

Ship stability diagram in the picture above shows the location of the points that affect the stability of the ship, where center of gravity (G), center of buoyancy (B), and Metacenter (M) at the position of the ship upright and tilt. For the record G is in a fixed position while B and M move when the ship tilts. In principle, there are three states of stability, namely Positive Stability (stable equilibrium), Neutral stability (Neutral equilibrium) and Negative stability (Unstable equilibrium).

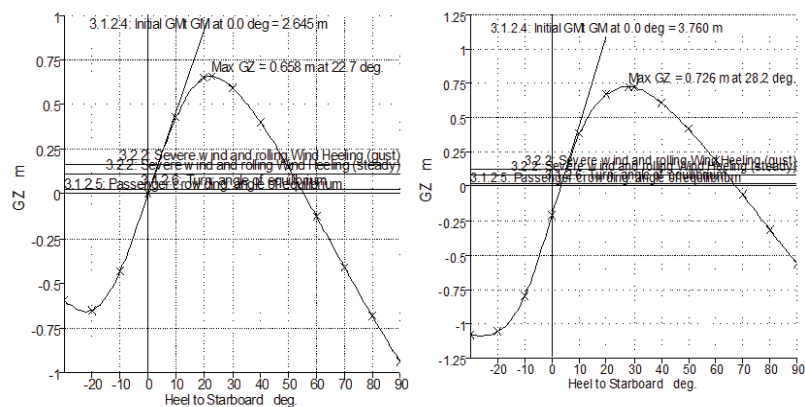
Figure 3: Graph of MDD and OSD Ship Stability in C3 Condition (Source: Analysis, 2018)

Based on *resume* The results of the above analysis show that the MDD ship failed to meet the IMO stability criteria under various shipping conditions in the Max GZ category where the Intact Stability is required for Max GZ the ship must have a moment of return when experiencing a tilt above 250 but the analysis results show that the ship MDD is only able to experience a maximum critical slope of 22.70, on the other hand, the OSD ship is able to meet all the stability criteria required in various shipping conditions, especially C3 where in C3 the OSD ship is capable of experiencing a critical slope of 280 where this value is above the standard value of 250 The graph of the stability of the two vessels in the C3 category can be seen in the following figure.

Based on the analysis of ship stability under various shipping conditions as shown in Table 2 and visualized in Figure 3, condition C3 and Figure 4, MDD vessels do not meet the IMO stability criteria, especially when the GZ slope is when the ship is on navigation with crowded passengers (C3). When juxtaposed with the hydro oceanographic data of Toba Lake, this critical condition is possible to occur at a wave height of 0.6 meters and above and is similar to the sinking situation of the KM Sinar Bangun ship where the influence of the waves hitting the ship and causing it to capsize until finally sinking also occurs when many movements crowded passengers who climbed down to the top deck while the ship was sailing and were hit by high waves.

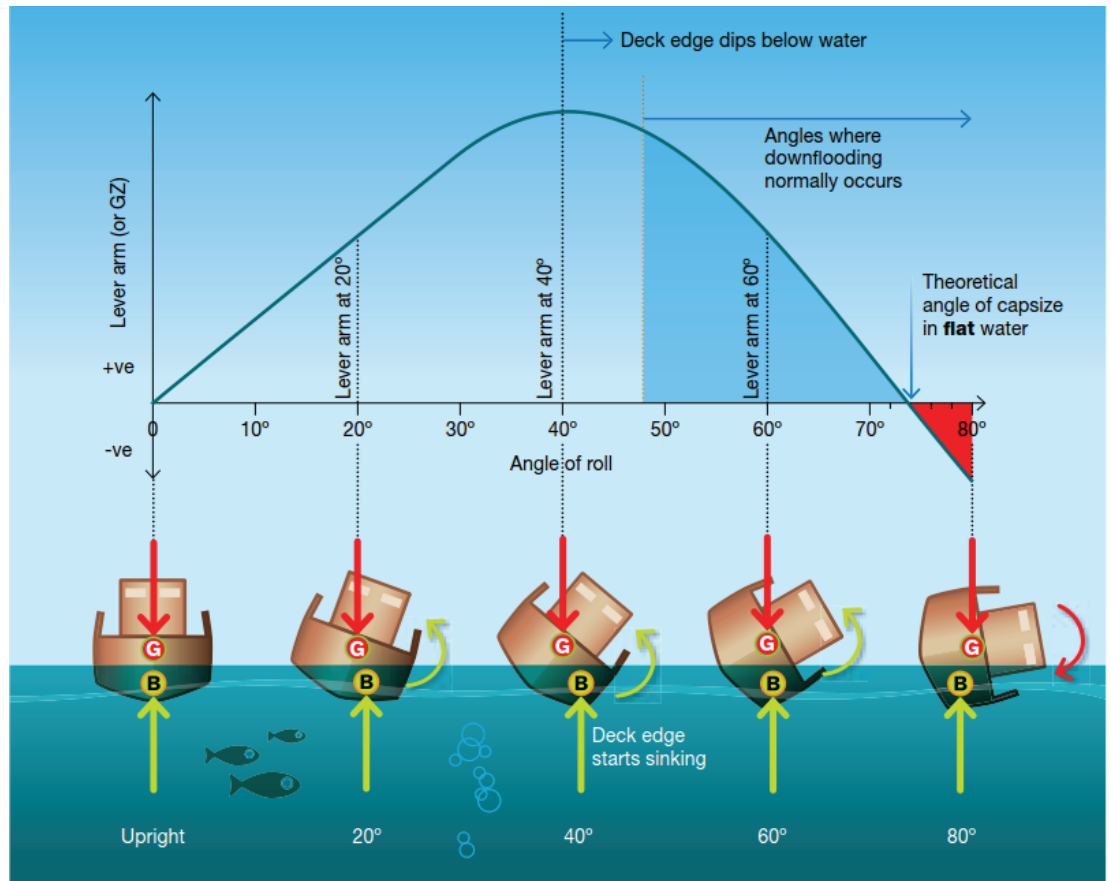
Figure 4: Graph of the ship's tilt stage against the stability curve (Source: Naval Architect and Marine Engineers (online), 2018)

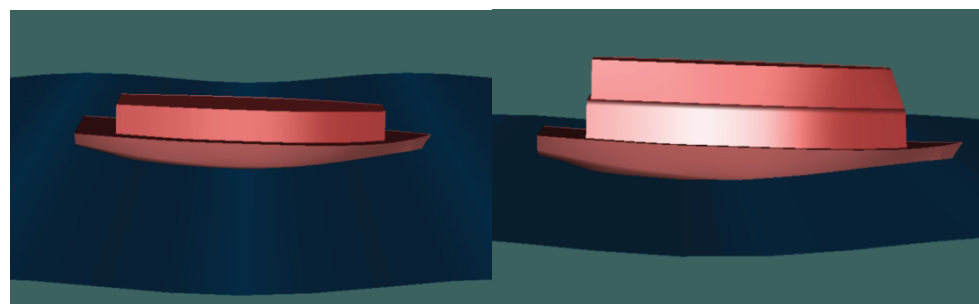
modification the addition of the passenger deck at the top level (right image) using the average speed of the ship, namely 6 knots, and normal wave height of 0.3 meters and a critical 0.6 meters.

Figure 5: Simulation of ship stability on perpendicular normal waves (Source: Analysis, 2018)

Based on the simulation results, it can be seen that in the critical condition the ship still has good stability when facing waves from the bow direction, while the prone conditions can occur when the ship gets the influence of waves from the side direction both in the diagonal and perpendicular side of the ship.

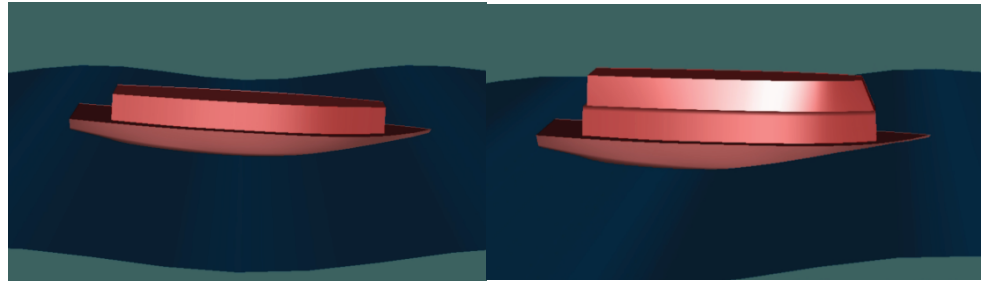
Figure 6: Simulation of ship stability at perpendicular critical waves (Source: Analysis, 2018)

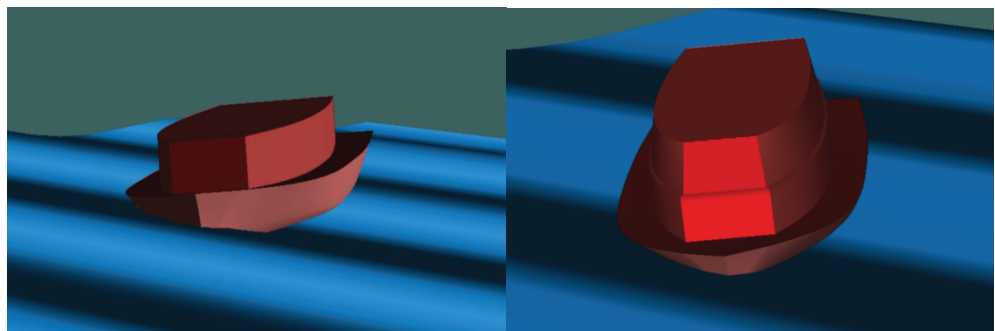
Figure 7: Simulation of ship stability on diagonal normal waves (Source: Analysis, 2018)

The ship condition of next simulation in Figure 7 and Figure 8 shows that when the ship is on a diagonal wave with a multilevel deck even though it still has a return moment at a slope of up to 24° , the prone condition that occurs is that the wave height becomes the same as the main deck so that water can enter the passenger cabin from side of the bow starting from midship to the bow. On the other hand, when a single deck vessel faces a diagonal critical wave, the water level also easily reaches the main deck, but the water does not flood or enter the passenger cabin.

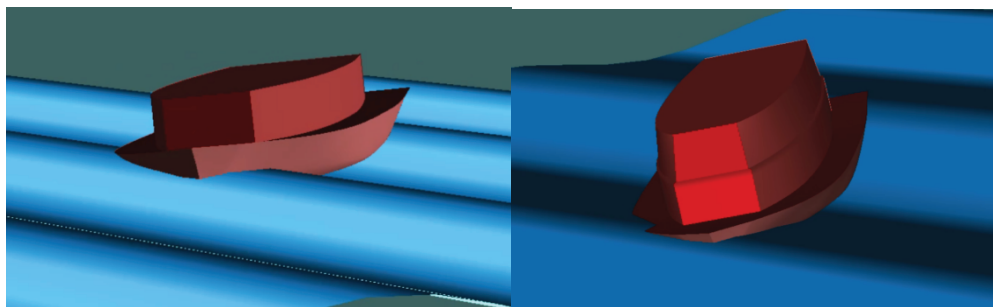
Figure 8: Simulation of ship stability on diagonal critical waves (Source: Analysis, 2018)

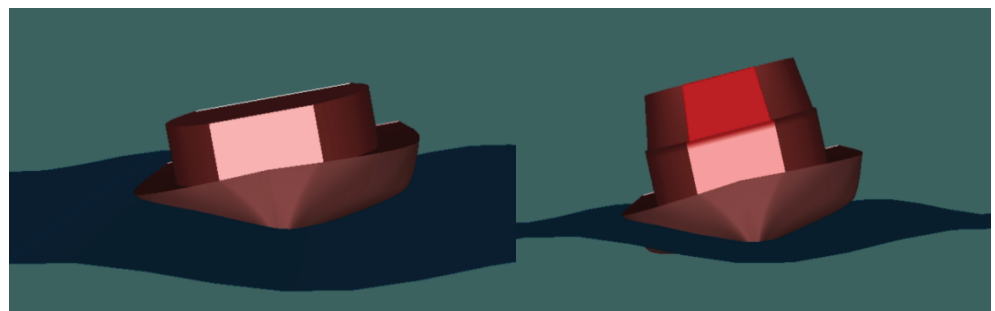
Figure 9: Simulation of ship stability on horizontal normal waves (Source: Analysis, 2018)

The most vulnerable condition is when the ship gets hit by waves perpendicular to one side of the ship, especially for ships with multilevel decks which can be seen in Figure 9 and Figure 10. In this condition, once the ship is at the crest of the wave, the ship will immediately tilt. and placing the entire side of the ship on the bottom of the wave so that the crest of the next wave is above the main deck. There are two conditions that may occur in this critical situation, The first condition is that the ship does not experience a tilt above 23° so that the ship still has a return moment during the shaking period even though when the ship moves back to its upright position the water has flooded the main deck, but if there are no openings that cause water to flood the passenger cabin on the main deck then conditions can still be said to be safe. The second condition is that the ship experiences a critical tilt at the bottom of the wave and no longer has a moment of return due to the transfer of the load at the same time

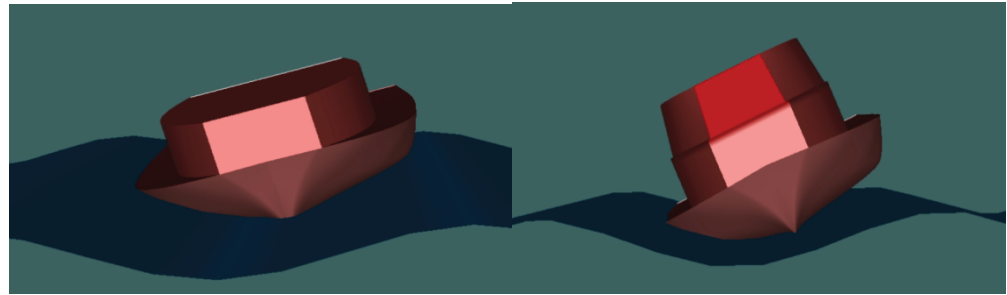
Figure 10: Simulation of ship stability on horizontal critical waves (Source: Analysis, 2018)

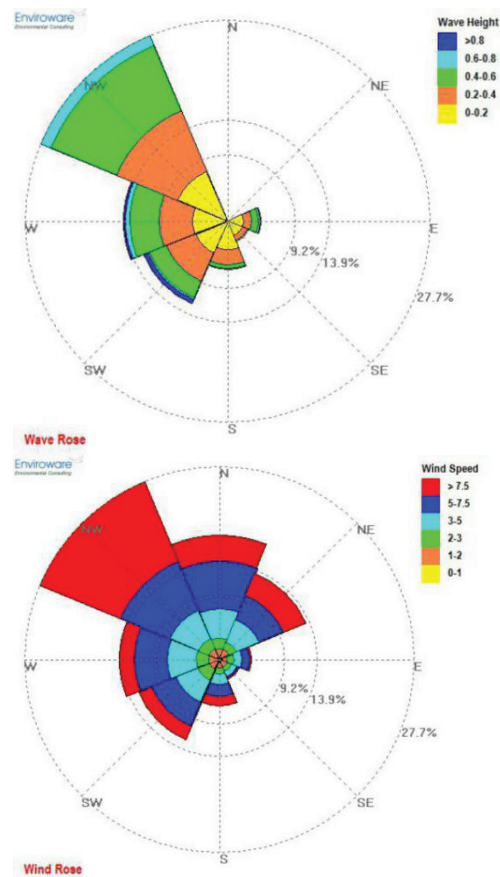
Figure 11: Waverose and Windrose at Sippinggan Port (Source: Sinaga, 2017)

Based on data of hydro oceanography condition at Sippinggan Port, Toba Lake, North Sumatra Province as the closest port from the data collection location was identified by the fact that the dominant representative waves and winds point to the northwest (NW) and west (W) and southwest (SW). The height of the representative waves leading to these three directions is predominantly in the range 0.2 - 0.6 meters. Even though the percentage is small, there is a chance that waves will occur with a height between 0.6 meters and above 0.8 meters. Generally, the wave period is 3 seconds. The most dominant representative wind conditions are to the northwest (NW) in the range of 5-7.5 knots and above 7.5 knots. In addition, the wind is also evenly distributed at a lower percentage in the north (N), west (W), northeast (NE) and southwest (SW) (Sinaga, Rosita. (2017). *Studi Penyusunan Rencana Induk Pelabuhan Sippinggan Kabupaten Samosir, Puslitbang Transportasi Laut, Sungai, Danau dan Penyeberangan, Badan Penelitian dan Pengembangan Perhubungan*).
